## TYPICAL TRANSVERSE INCEPTOR DRAINAGE

Figure 18-2I

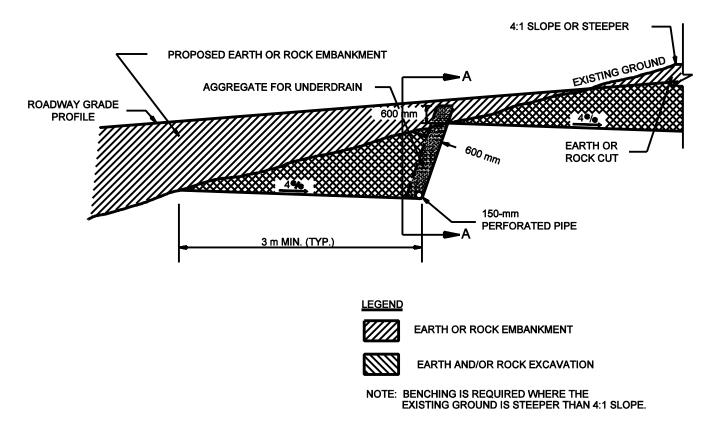
## **PROFILE VIEW**
